# **Navajo Abandoned Uranium Mine**

## **Site Screen Report**

### **Emmett Lee No. 3 AUM Site**

#### **Navajo AUM Western Region**

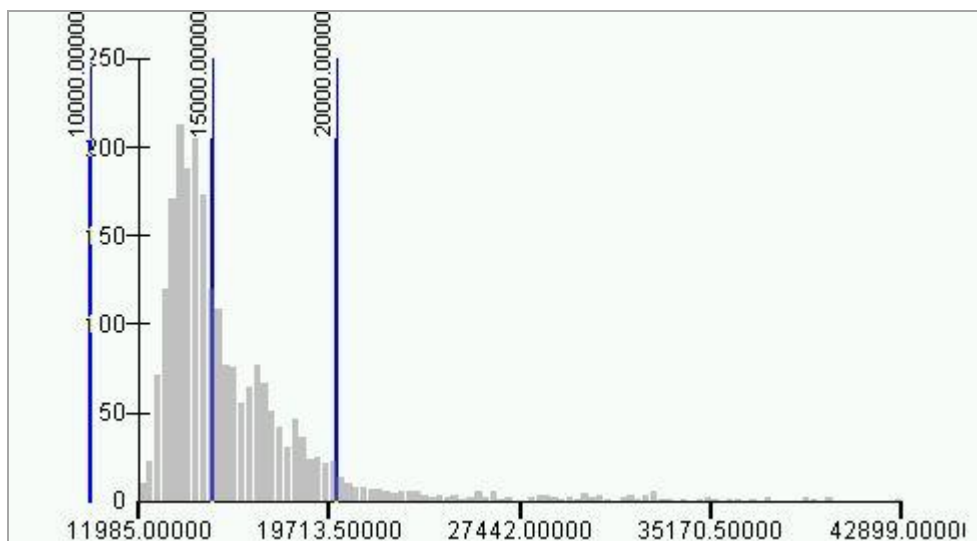
The following chart and statistics were generated by ESRI ArcGIS 9.3.1, and show the general distribution of the site gamma radiation measurements. The horizontal X axis represents the gamma radiation reading levels in cpm (lowest levels to the left). The vertical Y axis represents the frequency of each gamma radiation level.

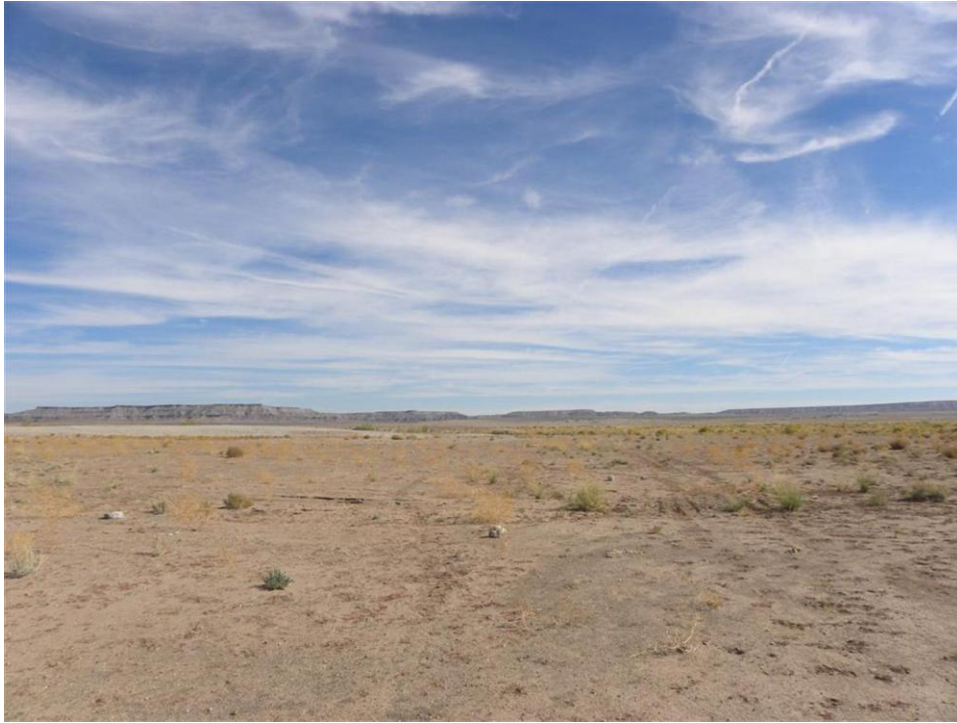
Photo 1. Emmett Lee No. 3 mine site

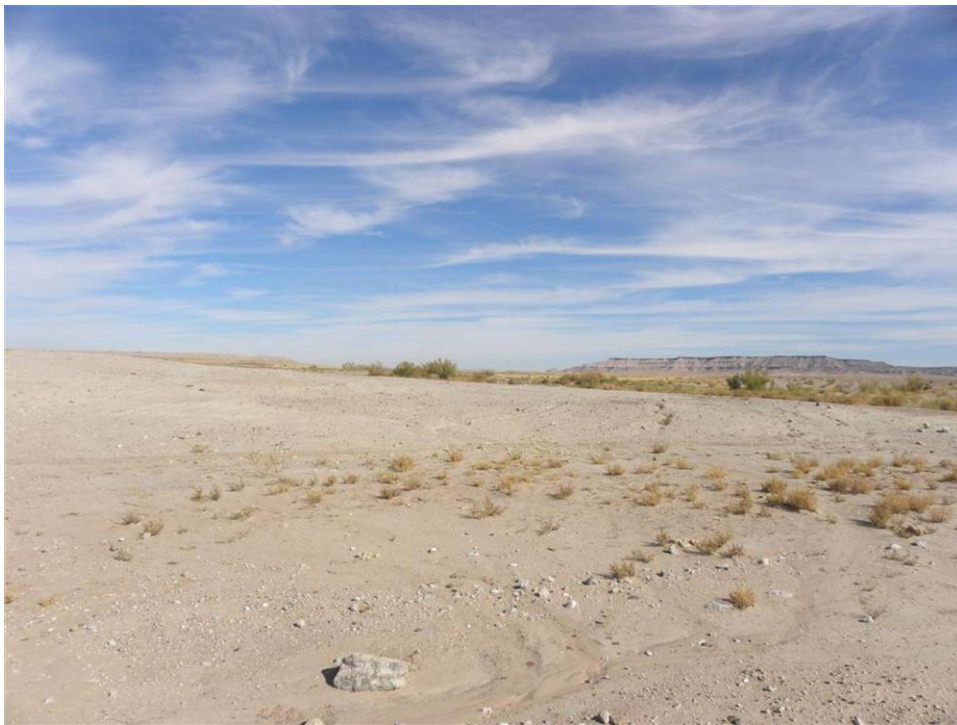
2 reclamation caps, shared with site #154: western cap 1000' x 300'; eastern cap 400' x 100', both made of grey material

Photo 2. Emmett Lee No. 3 mine site, reclamation cap

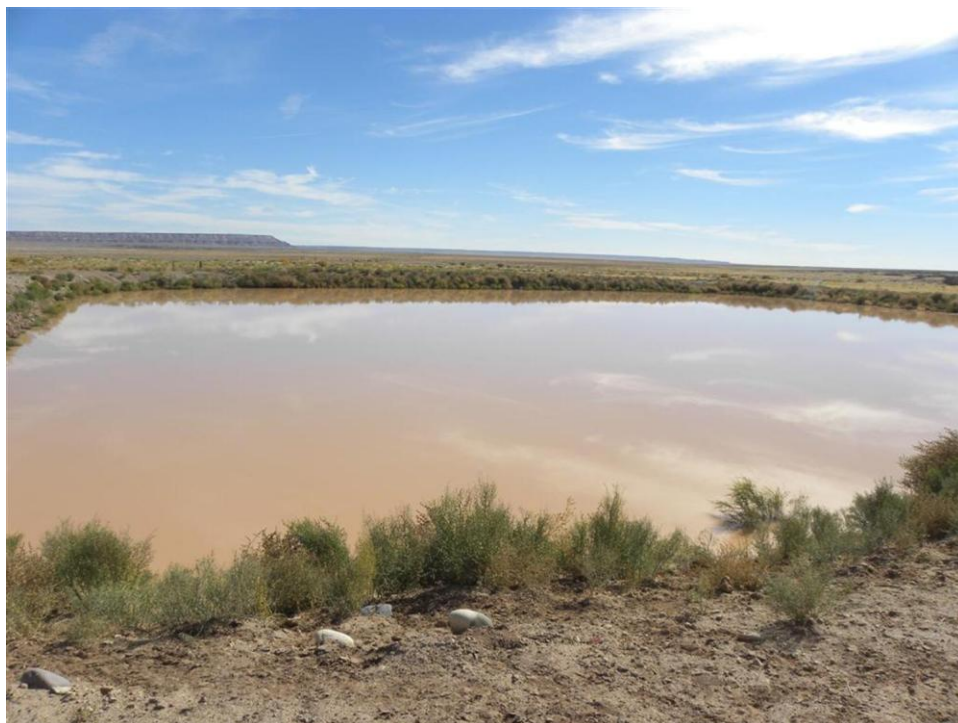
**0 to 0.25 miles:** Pond area behind livestock corral, approximately 500' E of the site

Photo 4. Emmett Lee No. 3, livestock corral pond 500' west of site

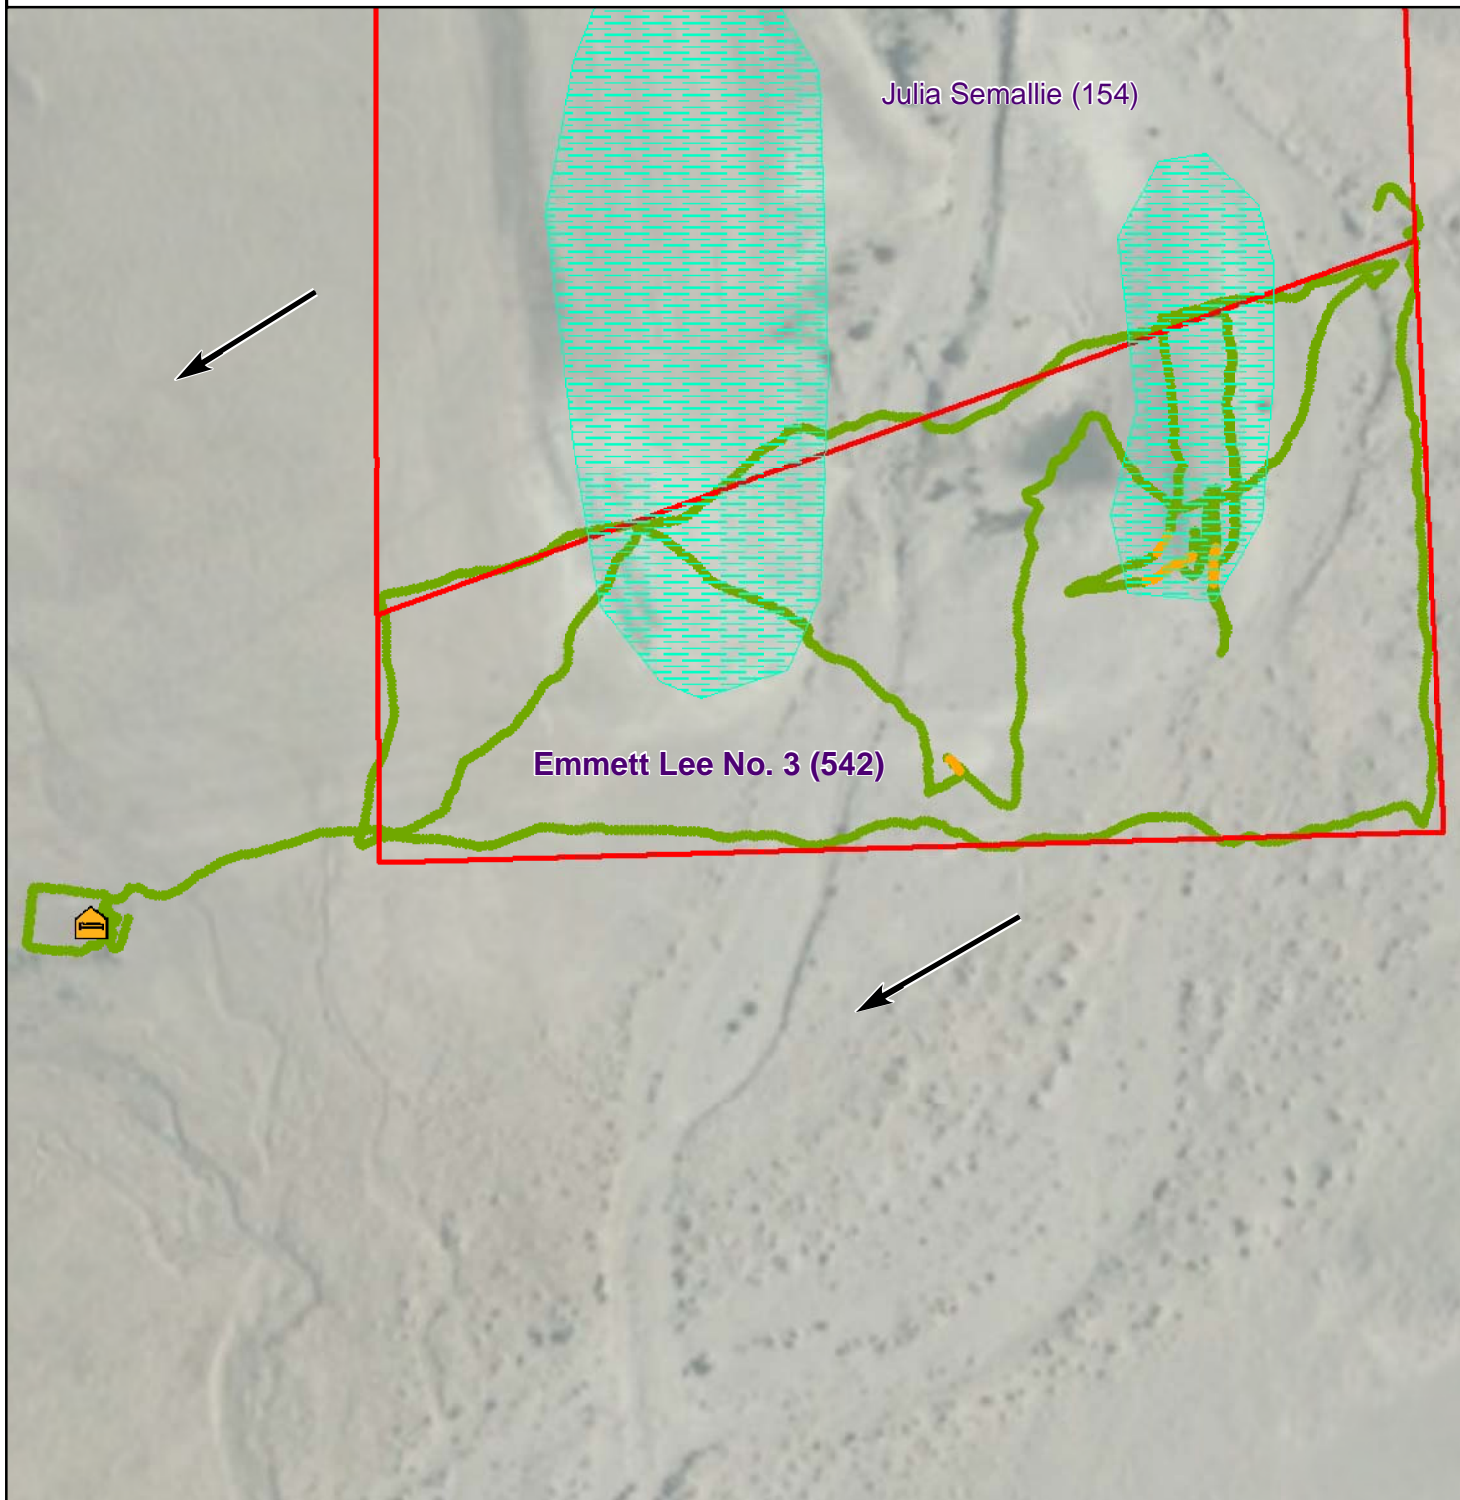
**Figure 1 - Gamma Radiation Measurements, Above Two Times Background  
Emmett Lee No. 3 (542)  
Coalmine Mesa Chapter, Navajo Nation**

A total of 2,287 gamma radiation measurements were collected from the mine site, ranging from 11,985 cpm to 42,899 cpm. The measurements collected at the reclamation caps were found at a maximum level of approximately 25,000 cpm, and in the eroded area of the eastern reclamation cap at a maximum level of approximately 40,000 cpm. The measurements are represented in Figures 1 and 2.

Gamma survey conducted 11/2010  
Measured as counts per minute (cpm)

Average background 13,707 cpm

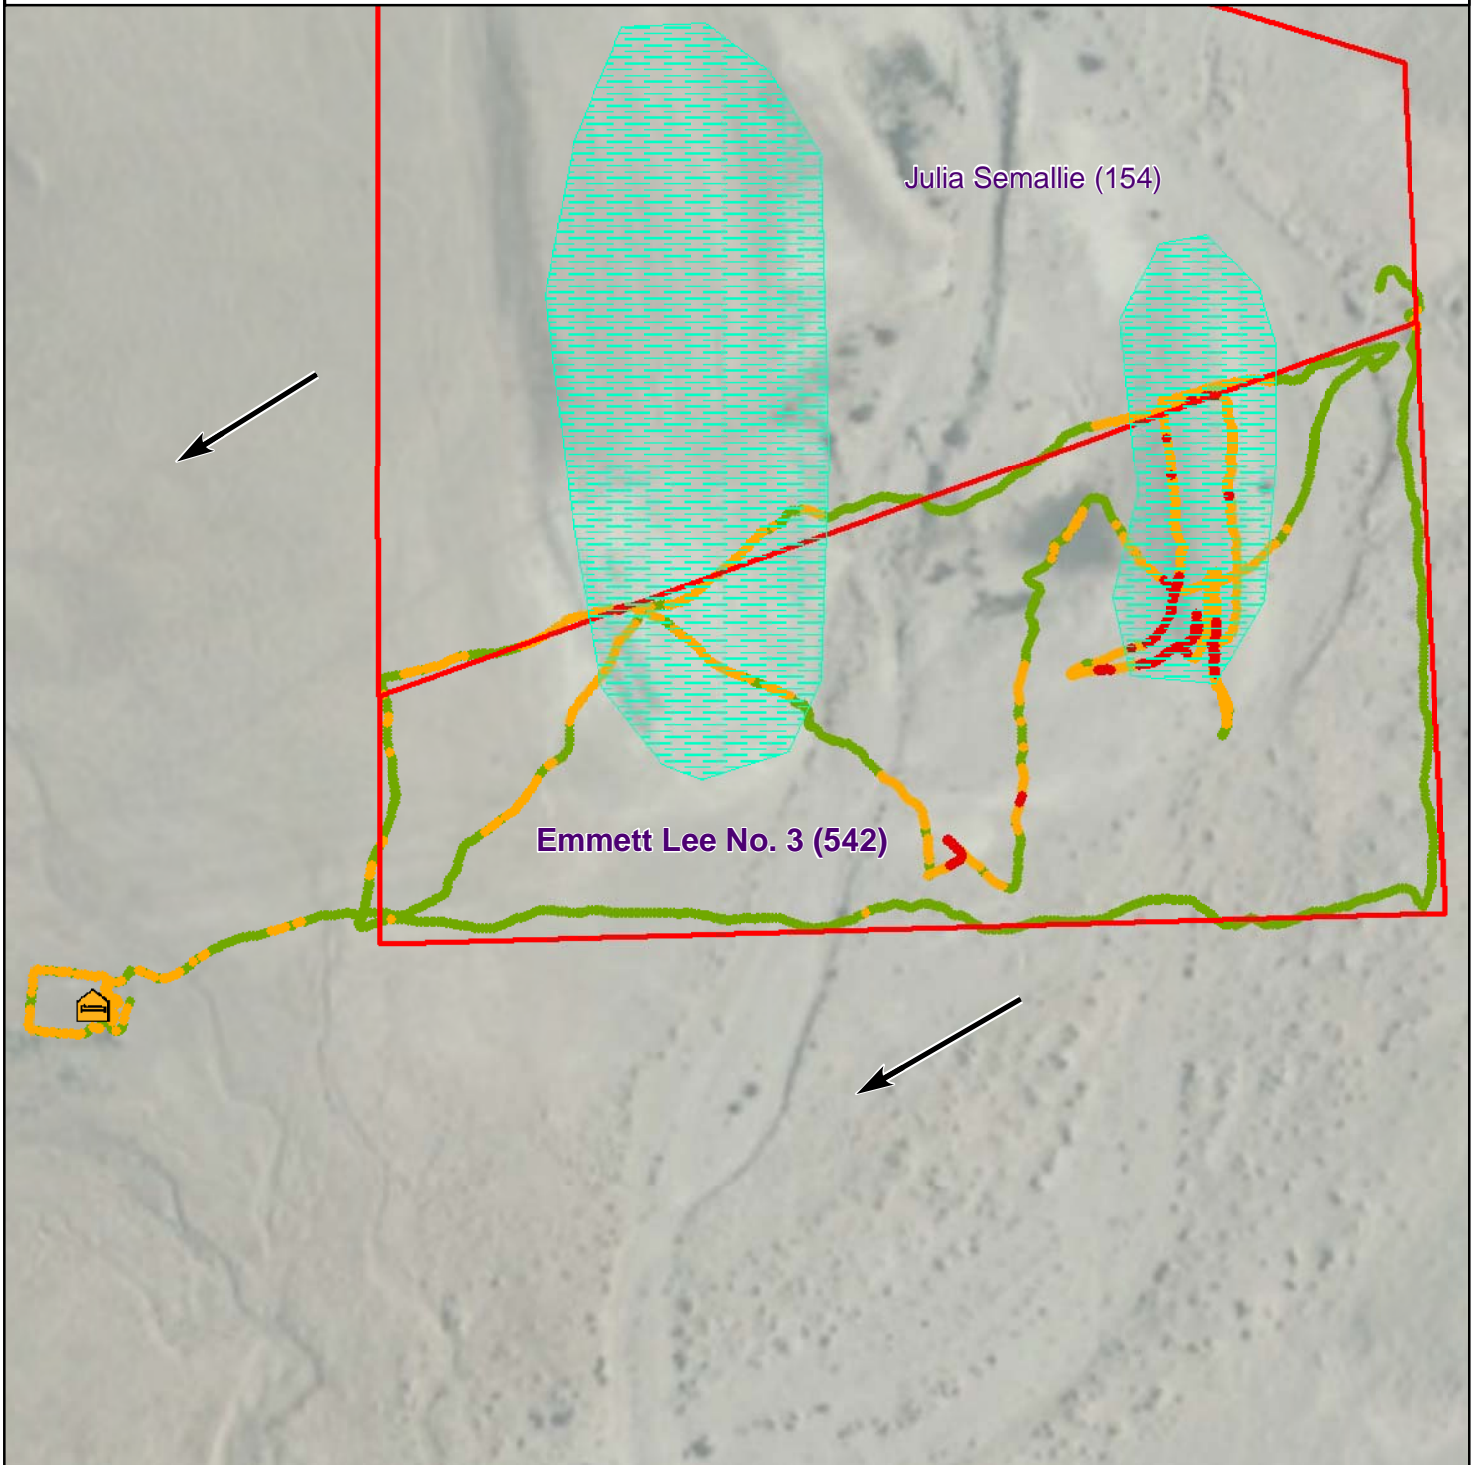
**Figure 2 - Gamma Radiation Measurements**  
**Emmett Lee No. 3 (542)**  
**Coalmine Mesa Chapter, Navajo Nation**

Gamma survey conducted 11/2010  
 Measured as counts per minute (cpm)

Average background 13,707 cpm
